Paper No. 03200 presented at Corrosion 2003, March 16 – 20, 2003, San Diego, California

INSTALLATION OF AN INSTRUMENTED CATHODIC PROTECTION SYSTEM ON A LARGE DIAMETER AST

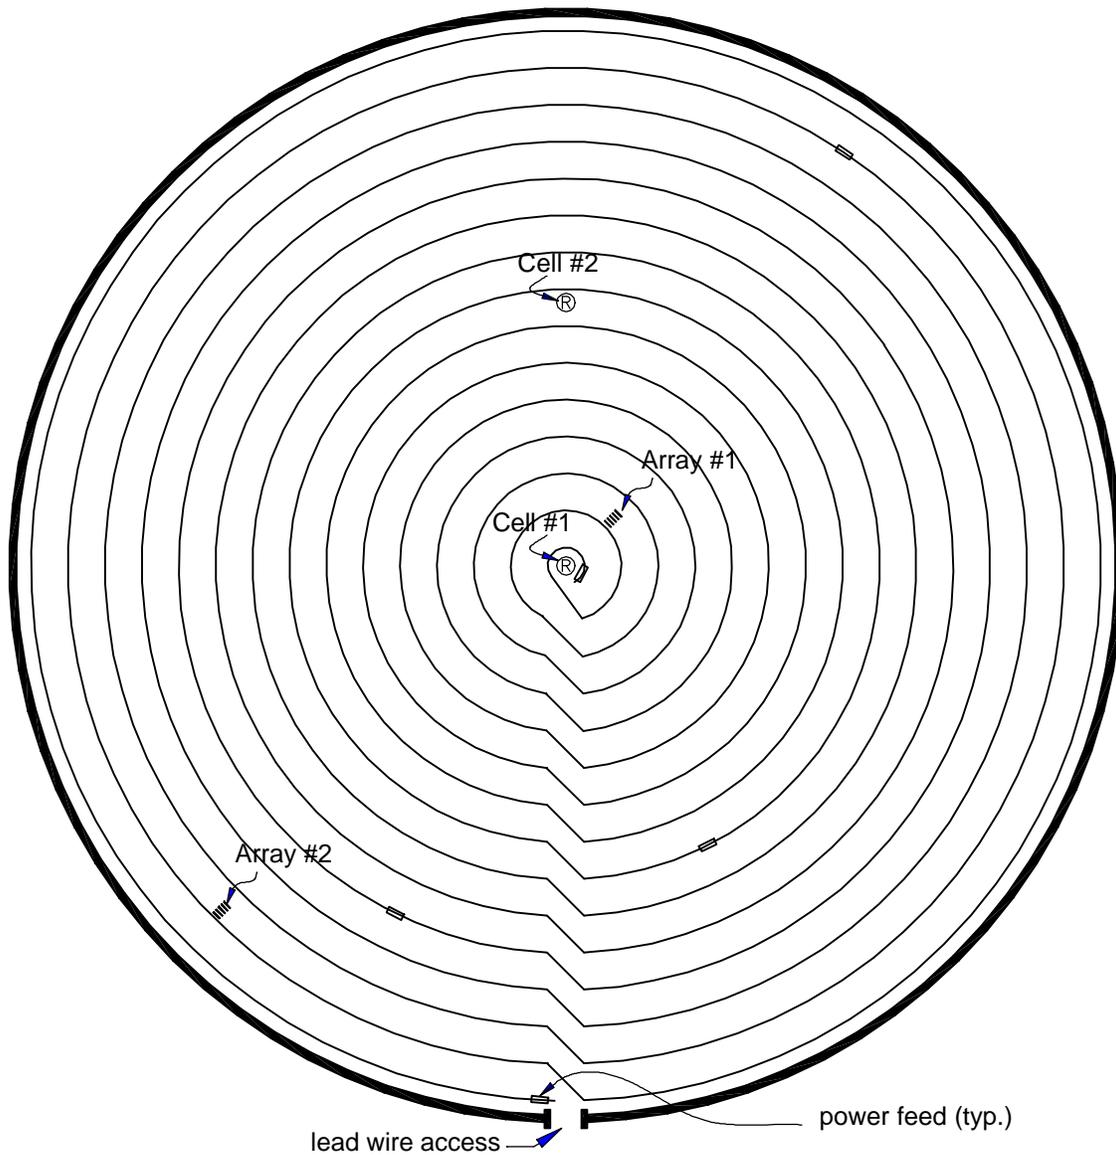
Anode Placement - First anode ring placed 2 1/2 feet (3/4 meter) in from outside edge. Subsequent anode rings placed 5 feet (1 1/2 meters) in from previous ring. Power feeds located at both ends and at three equi-spaced intermediate points.

Reference Electrode Placement - A single reference electrode is located at center (cell 1) and at mid-radius (cell 2). A five reference electrode array is located near the center (array 1, cells 3 - 7) and near the outer edge (array 2, cells 8 - 12). On each array, the cell furthest from the anode (#7 and #12) are fitted with CP coupons.

Figure 1 Plan view of the cathodic protection system installed between the primary and secondary containments on a 150 foot (45 meter) aboveground storage tank.

The installation was done in May 2001. The tank was opened up, cleaned, and the process begun. A liner was installed on the old floor and the anodes were placed directly on the liner. The first anode ring was placed 2 ½ feet (3/4 meter) in from the wall. Subsequent rings were offset 5 feet (1 ½

meters) in from the previous ring as the linear anode was gradually spiraled in toward the center. A power feed was plugged on to each end using the mating connectors; three additional power feeds were similarly connected at locations equally spaced along the anode length. Since all the anodes and power feeds are part of a single circuit, this multiple redundancy means that loss of any anode or power feed still allows current to flow to the entire anode array. The anodes were covered with an eight inch (20 cm) layer of sand.

Several operational tests have been performed in a laboratory environment, but very little testing has been conducted and reported on for actual field installations. The tank owner permitted us to install additional reference electrodes to more closely monitor the development of the polarization layer. Normally, a tank of this size would require three reference electrodes: one each at the center, mid-radius and near the outer wall. On this tank, twelve permanent references were installed. Two arrays of five reference electrodes each were installed; one near the center and one near the outer ring (see Figure 1). In addition, a single reference electrode was installed at the center and another at the mid-radius location. All reference electrodes were placed at a depth of four inches (10 cm).

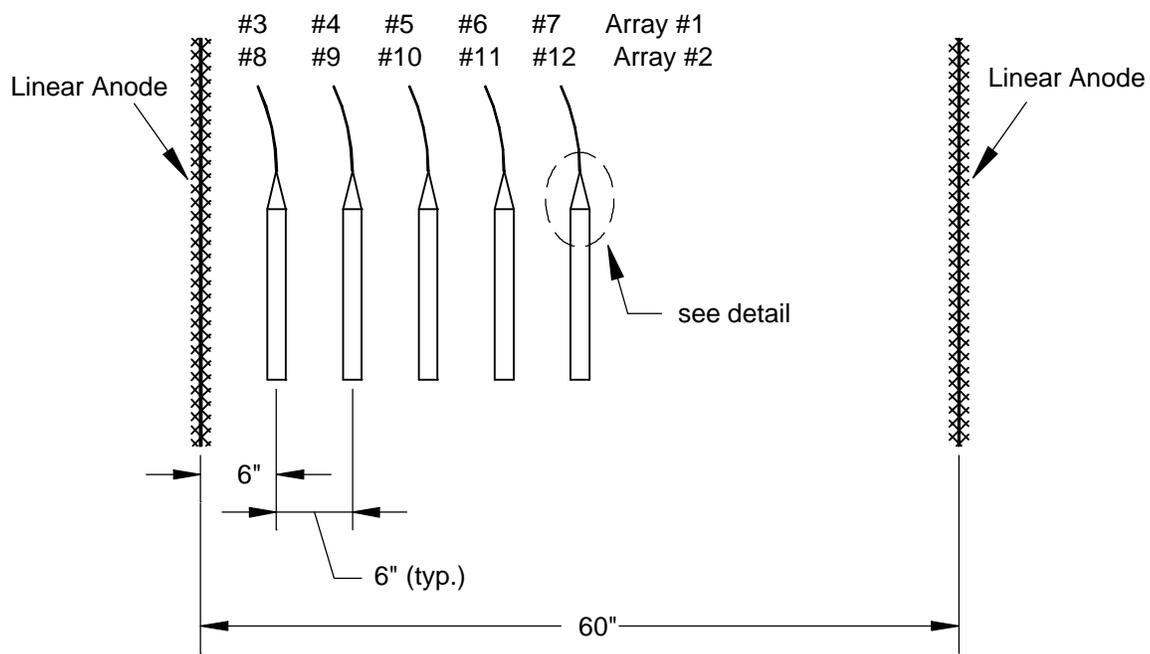
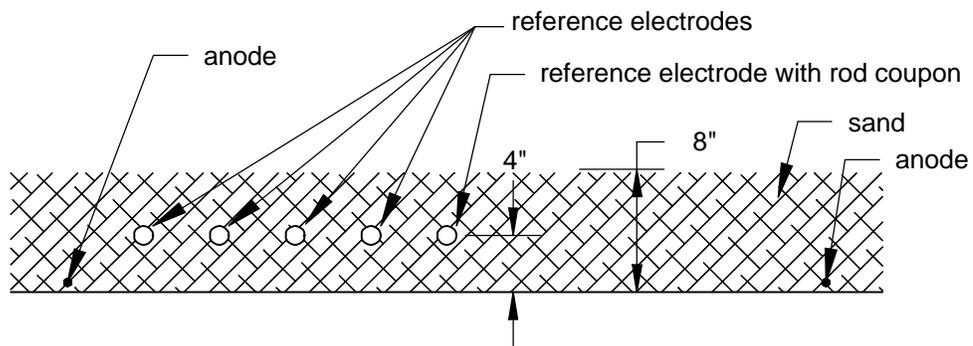
Detail - place coupon about 1/2" above bag of reference electrode.

Figure 2 Details of reference electrode arrays.

The reference electrode arrays are shown in detail in Figure 2. As stated earlier, the anodes were placed 60 inches (150 cm) apart. The five reference electrodes were equi-spaced from a location six inches (15 cm) away from the anode to a point midway between two anodes. The outermost reference electrodes in each array (the one mid-way between the anodes) was fitted with a steel rod coupon, 1/8" (3 mm) dia. X 2" (50 mm) long. This enabled us to make measurements with reduced IR drop error by measuring the instant-off potential when the coupon is momentarily disconnected from the tank bottom.

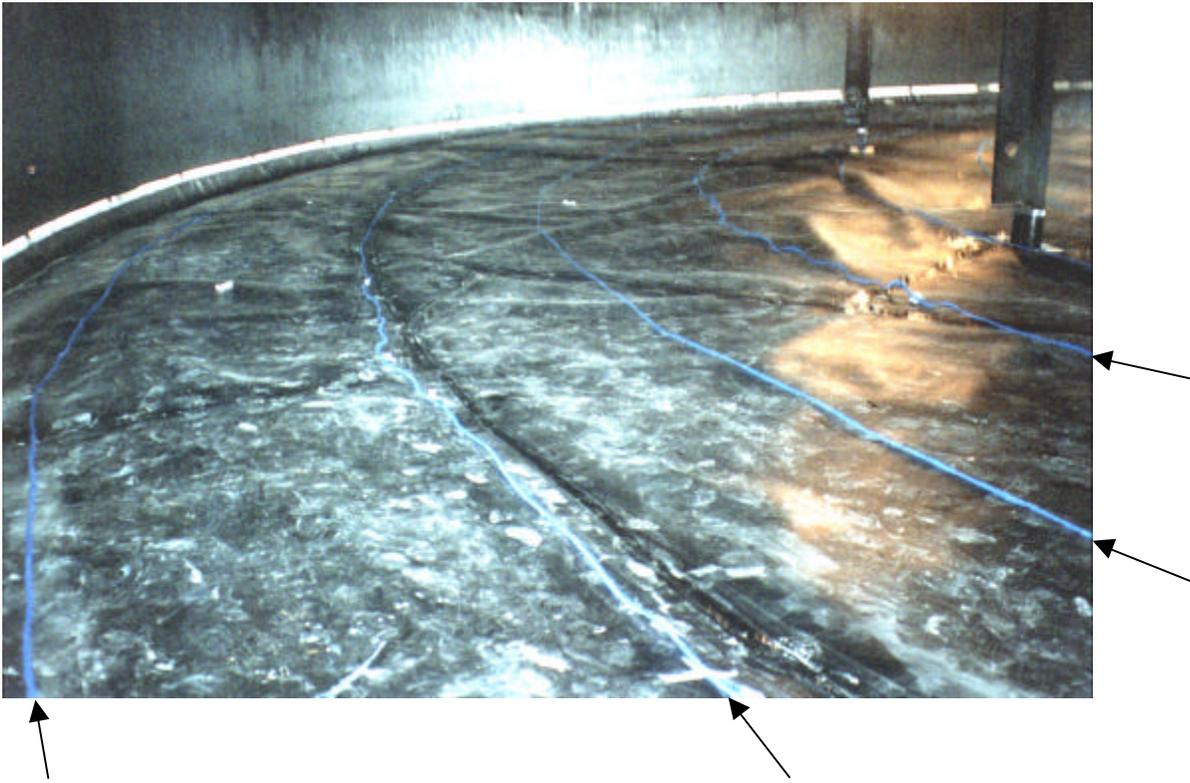
Figure 3a View of linear anode string resting on secondary containment (arrows designate anodes). The individual anode lengths are connected in the field and placed in a stepped spiral configuration, starting at the outside and working toward the center.

Figure 3a shows the anodes resting on the secondary containment in a stepped spiral pattern prior to placing the sand fill. Figure 3b shows one of the reference electrode arrays as installed. A section of anode is visible at the upper left while the rod coupon can be seen next to the reference electrode at the lower right. The total length of anode required was 3,650 feet (1,100 meters). A three-person crew was able to complete the anode installation in 6 ½ hrs. After the remaining sand was emplaced, two people installed the reference electrode arrays in about 2 hours. A new floor was then installed on the sand bedding. The anodes are powered by a 24 amp rectifier; the anode material is designed to operate at this current level for 40 years.

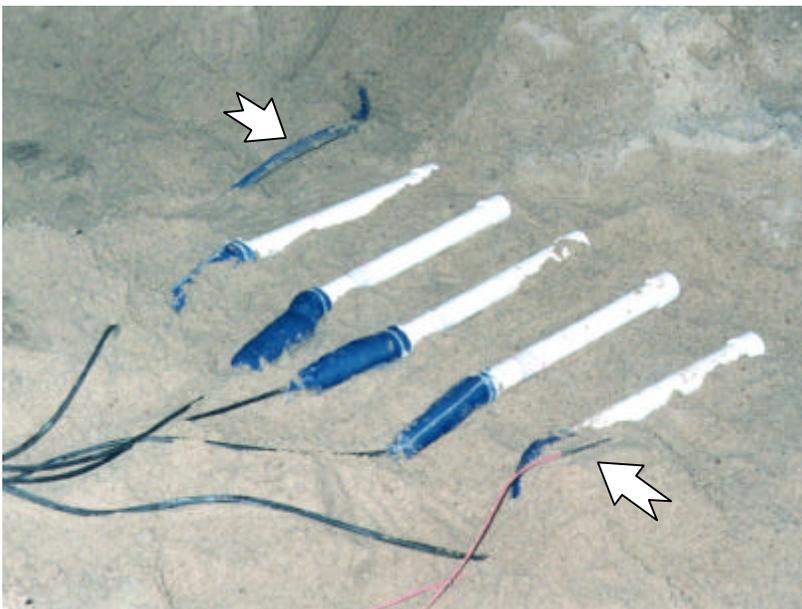
Figure 3b View of one of the reference electrode arrays. The anode is visible in the upper left part of the photo; the coupon can be seen resting on the reference electrode at the lower right.

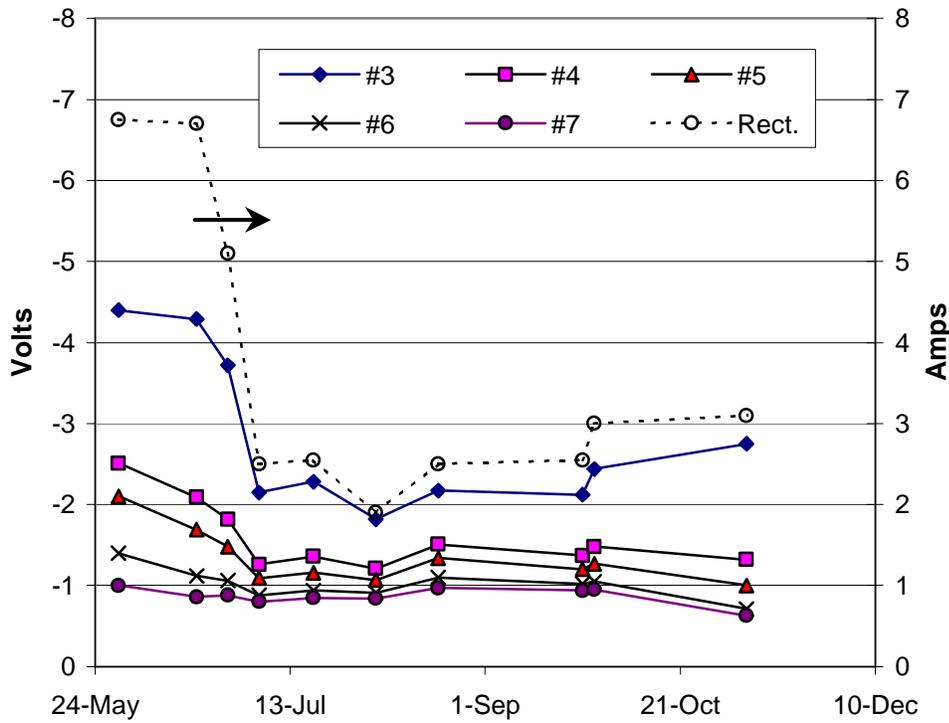
Figure 4a Current-on potentials from Array #1. Reference electrode #3 is located six inches (15 cm) from the anode. The remaining reference electrodes are located 12, 18, 24 and 30 inches (30, 45, 60 and 75 cm) from the anode. The closer the reference electrode is to the anode, the greater the IR drop error in the reading.

IR drop error for current-on measurements can be significant in this environment due, in part, to the high electrolyte resistivity. One would expect the error to be highest at a location closest to the anode and drop off to a minimal level at a point midway between the anodes. This is, in fact, the case as can be seen clearly in Figure 4. Figure 4a shows current-on potentials as measured by the five references in Array #1 near the tank center. The reference closest to the anode, #3, gave the most negative readings and the measurements became less negative closer to the mid-point between the anodes

(#7). The magnitude of this error varied directly with the rectifier output as it was being adjusted during the commissioning phase. Similar data from array #2 is shown in Figure 4b. It is important to note that in order to get meaningful potential measurements, it is critical that the reference electrode be as close as practical to the exact mid-point between adjacent anodes.

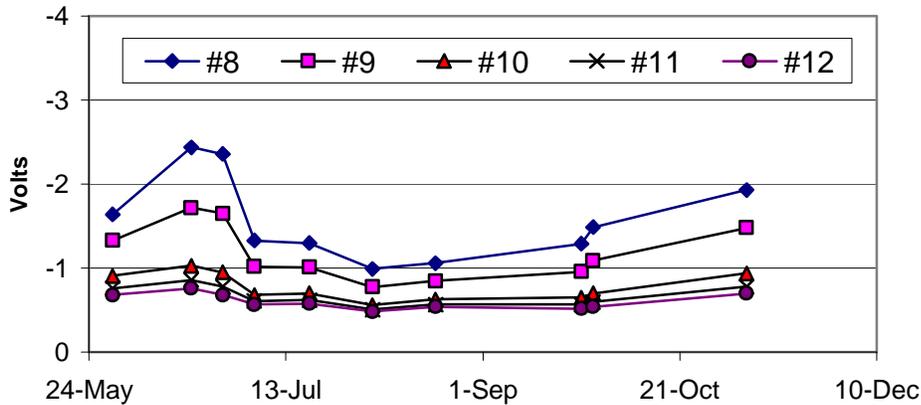
Figure 4b Current-on potentials from Array #2. The reference electrode spacing is similar to that in Array #1.

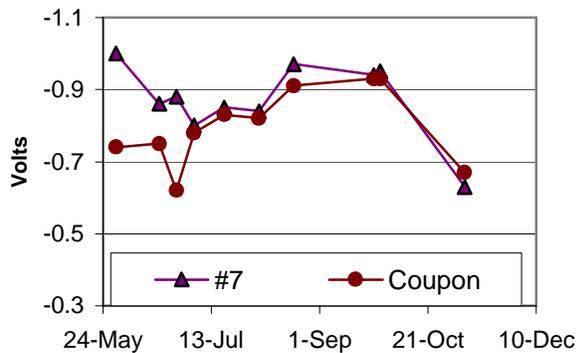
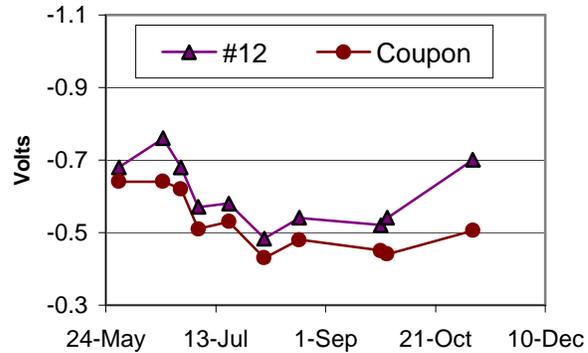
a) Data from Array #1

b) Data from Array #2

Figure 5 The current-on potential measurement from a reference electrode located mid-way between anodes is contrasted with the instant-off potential (coupon disconnected from structure) of adjacent coupon. When the reference electrode is exactly centered between the anodes, the difference in these readings will be minimal.

Figure 5 contrasts the current-on potential measurement made by the reference electrode closest to the midpoint with the IR drop free measurement made with the adjacent coupon. To make this measurement, the instant-off potential of the coupon was measured when it was momentarily disconnected from the structure. For reference #7 (Figure 5a), the two readings were virtually identical which suggests that it was located very close to the mid-point between anodes. This was not the case for reference #12 (Figure 5b). Since small differences in location can have large effects on the amount of IR drop error incorporated into potential measurements, it is not a good idea to rely just on accurate electrode placement to get IR drop free measurements. For the most accurate measurements, it is necessary to either interrupt the rectifier or use coupons.

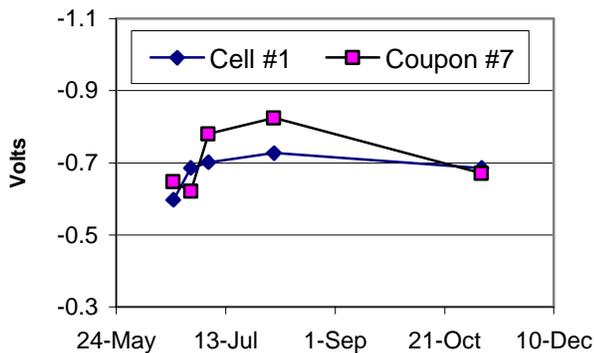
Figure 6 A close correlation was observed between instant off potentials measured at Cell #1 (center, rectifier interrupted) and Coupon #7 (10 feet away, coupon momentarily disconnected). Either method can be used to measure IR drop free potentials.

Figure 6 illustrates the close correlation which exists between instant off measurements made by interrupting the rectifier (Cell #1) and those made by momentarily disconnecting the coupon from the structure (Coupon #7). The two measurement locations are about ten feet (3 meters) apart at the center of the tank. The two measurements converged as the polarization became more uniform with the passage of time. This data can also be interpreted as a demonstration of the amount of polarization which has occurred. This is done by subtracting the native potential from the instant off potential measured at that location. Figure 7 shows the polarization measurements made at two locations: the center (Cell #1) and the mid-radius (Cell #2). Throughout the entire commissioning period, the potentials at both locations exceeded the 100 millivolt shift NACE criterion.

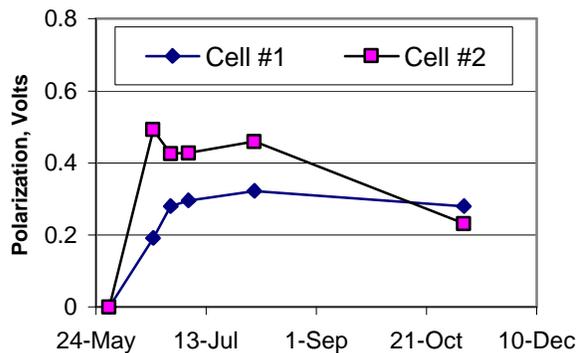
Figure 7 The amount of polarization at the center (Cell #1) and the mid-radius (Cell #2) remained well above the 100 mV criterion as the current level was adjusted. The final current level was set at 0.17 mA/sq. foot (1.7 mA/sq. meter).
